**Inspection Report**  
**Minerals Regulatory Program**

**Mine Name:** Torrey Buff

**Operator or Permittee Name:**  
State Stone

S/055/021, State Stone's Torrey Buff Mine

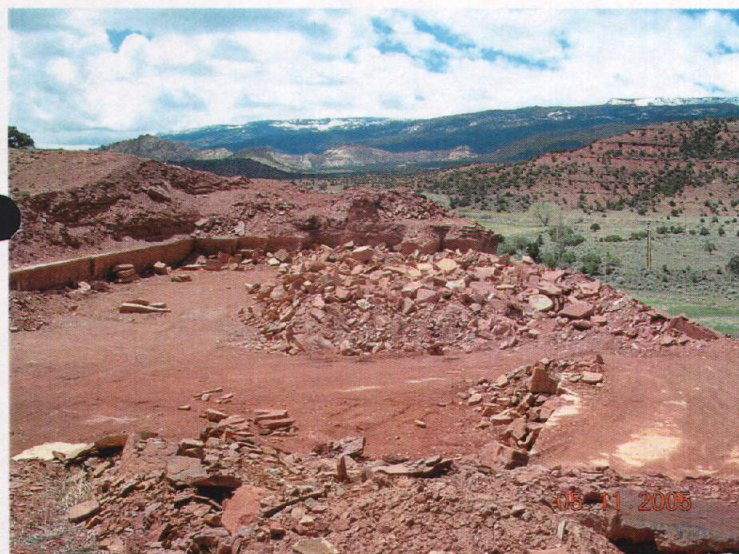
The processing/loading area at the west quarry is flat and fairly smooth (Photo 3). We found a few seedlings, mostly next to rocks. There was a fair amount of halogeton. Although there could still be more germination this year, I am concerned about the lack of vegetation.

Because of the lack of seedlings in the processing/loading area (see below), we took soil samples from this area and from an adjacent undisturbed area. My primary concern is whether the soils have high salt concentrations.

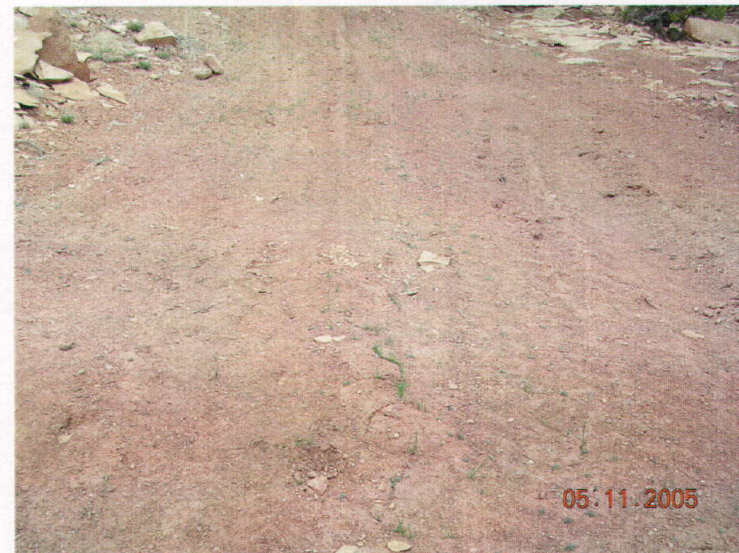
At the east quarry, we found a lot of grass seedlings in the regraded areas (Photo 8). Like the processing/loading area at the west quarry, this area was also left very smooth, and I was surprised how well the grass was germinating.
